PROGRESS OF CONSTRUCTION WORK

Bloor Collegiate Institute Update

March 25, 2024

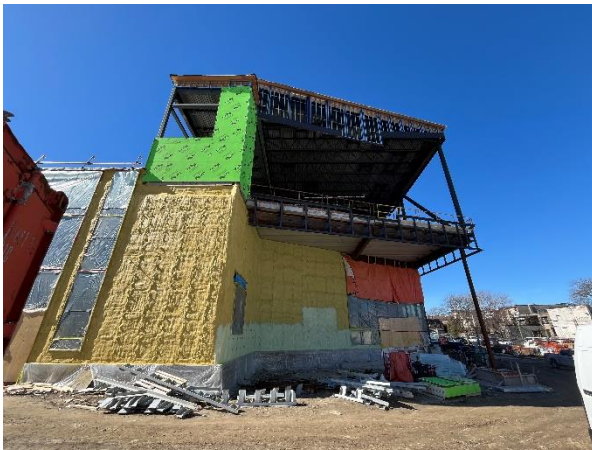
Exterior photo of the North-East corner looking at the North entrance. Third floor and roof structural steel and steel deck was completed in the past month. Spray foam was recently completed.

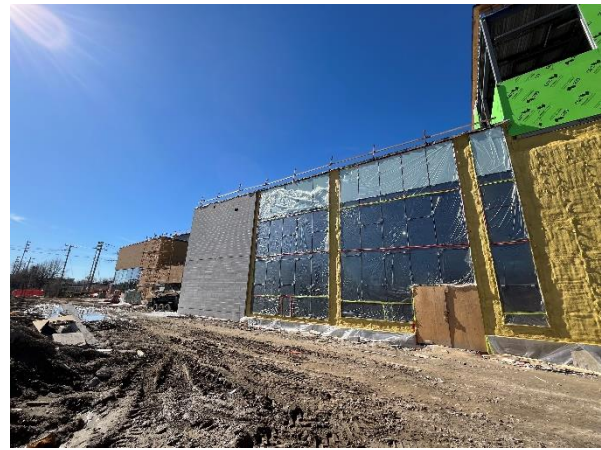
Exterior photo of the East side of the building looking towards the student commons area. Parapets have been built up, and roof is complete. Exterior block veneer and curtain wall glazing was recently installed. Spray foam was recently completed.

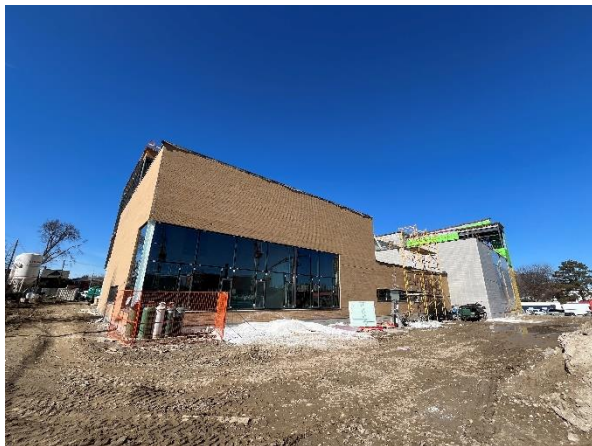
Exterior photo of the South-East corner looking at the Music Room. Exterior brick and curtain wall glazing was completed in the past few months. Parapets are built up and roof is complete.

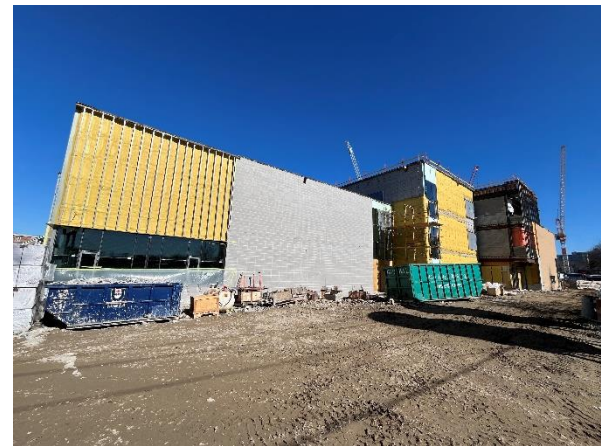
Exterior photo of the South-West corner of the building, looking at the gym. Spray foam insulation was completed in the past few months and the exterior block veneer was recently installed.

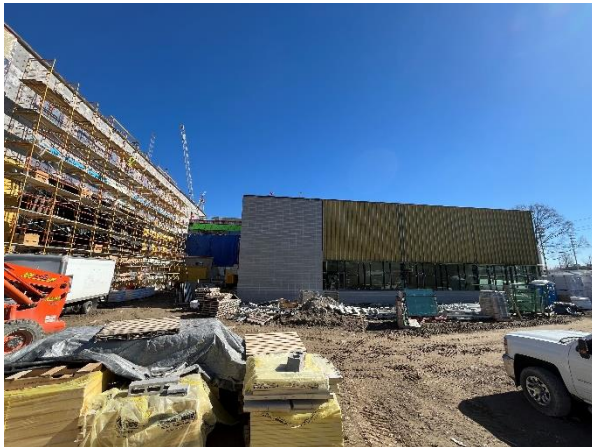
Picture taken from the South-West corner of the building looking at the Gymnasium. The exterior block veneer was recently installed.

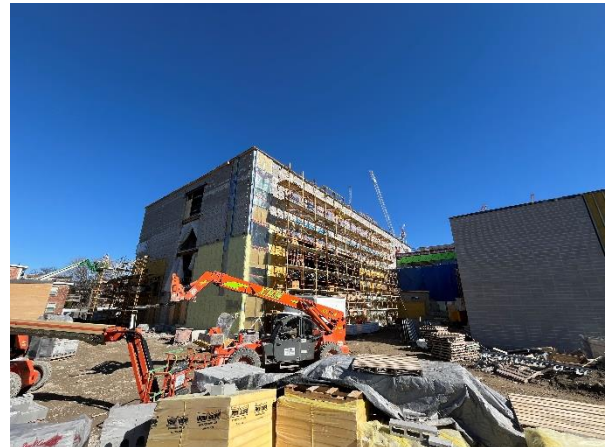
Picture taken from the West side of the building looking at the courtyard. The punch windows were recently installed and they are currently spraying the block wall with the foam insulation.

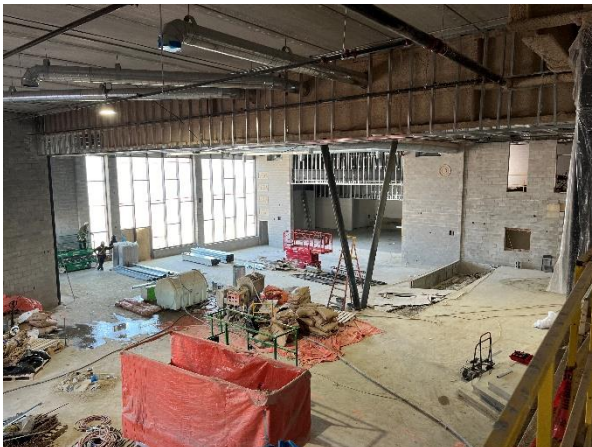
Picture from the second floor looking down into the student commons area. Fire rated spray foam has been applied to exposed structural elements and bulkheads have recently been installed.

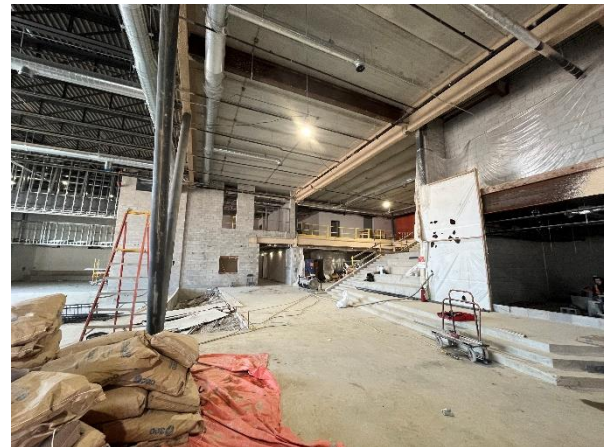
Picture from the North-East entrance looking towards the student commons area and main office. Rough-ins have been completed for some time now. Fire rated spray foam has been applied to exposed structural elements and bulkheads have recently been installed.

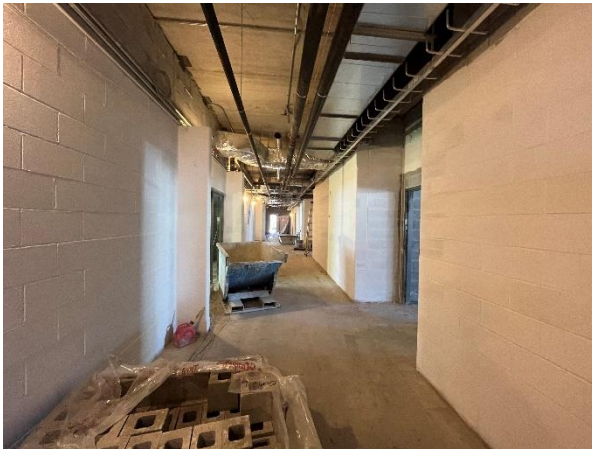
Picture looking down the ALPHA II Alternative school hallway. Rough-in are complete and block walls were recently primed.

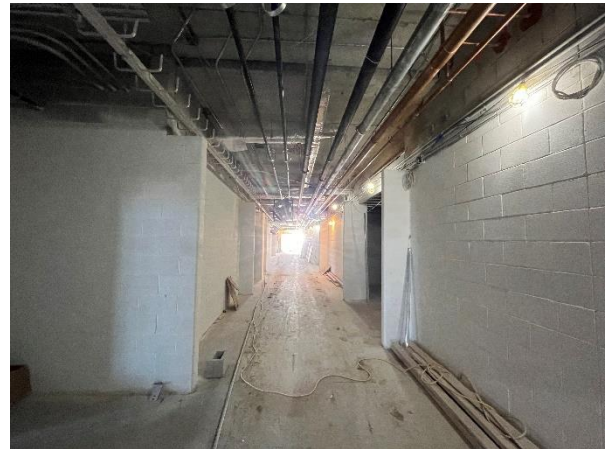
Picture looking down the North/South hallway of the first floor. Rough-ins have been completed for some time now and block walls were recently primed.

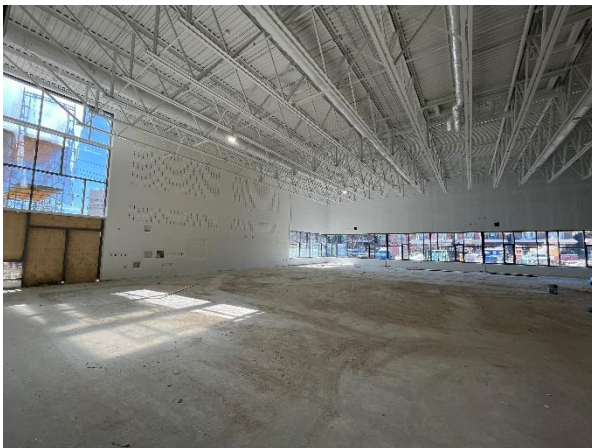
Picture of the gymnasium. Curtain wall glazing was completed a few months ago and the entire room was recently primed.

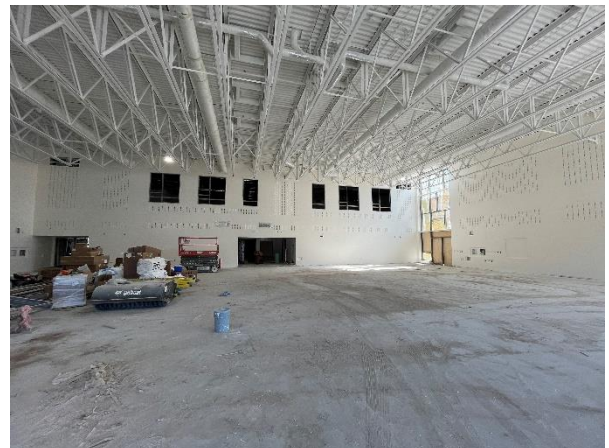
Picture taken within the gymnasium looking up at the Computer Engineering classrooms. The gymnasium was recently primed.

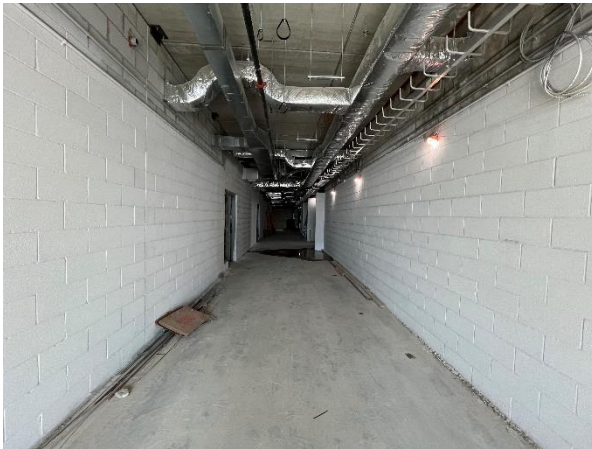
Picture of the hallway on the second floor. Rough-ins are about 95% complete and block walls were recently primed.

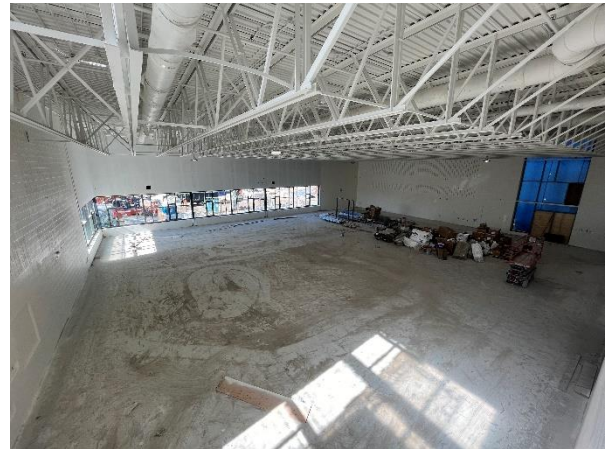
Picture from the Computer Engineering room looking down into the gymnasium. Ceiling and walls were recently primed.

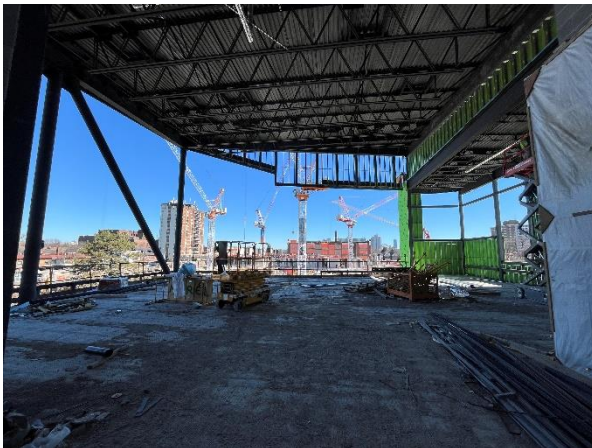
Picture of the library from the entrance doors. Steel room deck was recently completed.

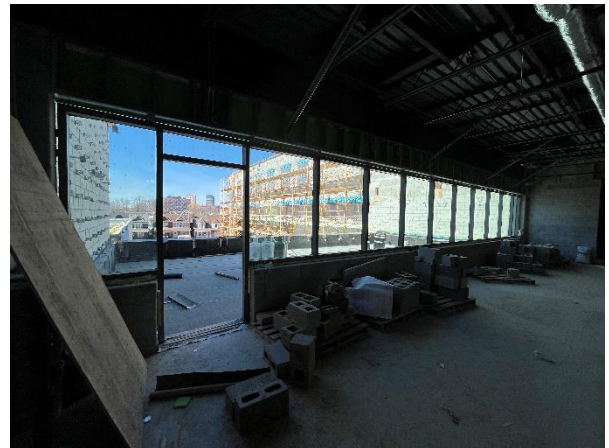
Picture from third floor hallway looking at the outdoor learning roof. The roof membrane was installed a few months ago.

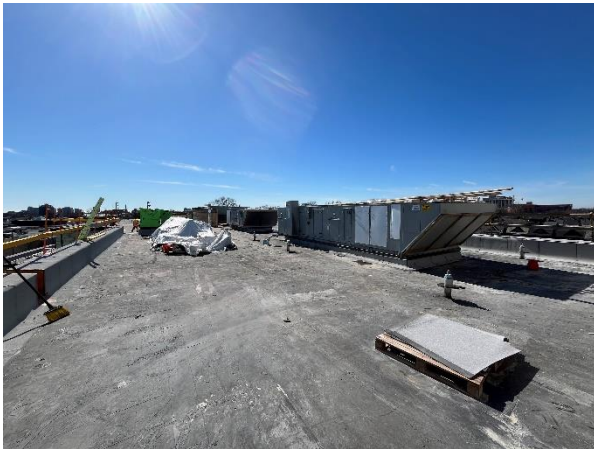
Picture of the third-floor roof completed a few months ago and the mechanical rooftop units installed recently.

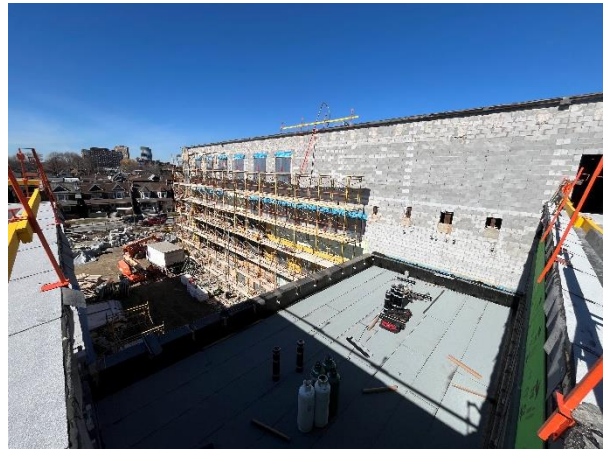
Picture from the third-floor roof looking down into the courtyard. Scaffolding erected to apply the spray foam insulation and the exterior block veneer.
